# Modern Technology Used to Determine Extent of Underground Mine Fire

*By Tim Wilson, Environ. Scientist  
Surface Mining Section*

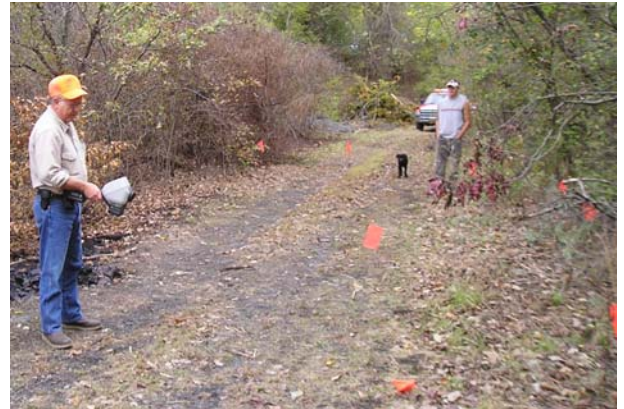
**KDHE crews survey the extent of the underground mine fire through the use of Crawford County's thermal imaging camera.**

Extinguishing the current fire will be handled in the same manner as the 2002 fire. Large excavators will dig a cut off trench around the burning area to contain the fire and stop it from advancing further toward the residence. The excavator will then expose and spread the burning material while saturating it with large amounts of water. Once the fire is put out, the burned material will be reburied and the affected area will be covered with clay for revegetation with grasses. Funding for this type of project is provided by individual emergency grants to the state from the federal Office of Surface of Mining. The current project should be completed by the end of October.
